Abstract: Since the year 2000, the city of Gweru has had an unprecedented proliferation of unattended potholes on most of its roads. These potholes have caused discomfort to the motoring public, caused death to others and damaged vehicles. This paper presents the results of a study that sought to establish the spatial distribution of potholes and determine their socio-economic impacts in Gweru's residential areas. Pothole location and dimensions were measured in the field whilst interviews and questionnaires were administered to vehicle owners, motor mechanic experts, drivers and the travelling public to determine their socio-economic and mechanical impacts. Stratified, convenience and purposive sampling methods were used in the selection of study streets and respondents to questionnaires and interviews. Results revealed that potholes are more concentrated in high density residential areas. Other causes of pothole formation identified during this study are poor drainage on the roads, rainfall impact, advanced age of roads, poor or lack of maintenance, type and volume of traffic as well as the effect of tree-root prying on paved surfaces. It is recommended that Gweru City Council en

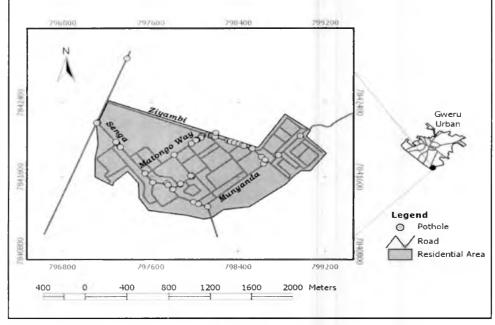
A total of 47 potholes were analysed on sampled roads in Senga and Nehosho residential areas. A stretch of about 11 m × 6 m at the intersection of Ziyambi Drive and Matongo Way and a 20 m × 6 m stretch along Ziyambi Drive are now more of gravel than paved surfaces. 36% of the studied potholes were small (less than 150 cm in circumference), 34% were medium sized (151-300 cm in circumference) whilst 30% were large (more than 300 cm). Large potholes at some points such as at the intersection of Chiwaya Street and Senga Road have circumferences averaging 568 cm, diameter of 242 cm and 6.2 cm in depth covering almost the whole lane. The distribution of potholes recorded and measured on sampled streets in Senga and Nehosho high density areas is shown in Fig. 3.

Fig. 3 Distribution of potholes on sampled streets in Senga-Nehosho residential area.

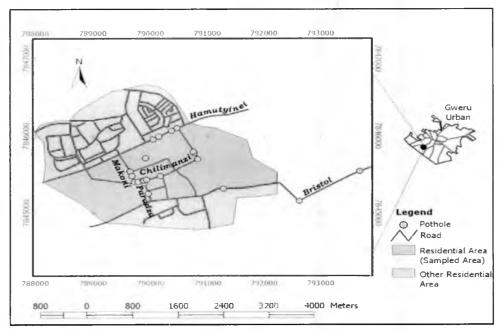
There were about 17 potholes recorded on sampled roads in Mkoba 6/7. Patching work using pit sand had just been done on several roads at the time of study but Paradza Road linking Mkoba Road and Chilimanzi Road had not been patched despite clear evidence that the city council was through with maintenance work in the area. This was because the city council targeted major roads only. At the intersection of Chilimanzi and Hamutyinei Roads the formerly tarred surface is now just a gravel surface. Observations showed that the main cause of damage along these two roads were the construction trucks heavily loaded with sand, bricks and concrete to the recently established residential area where the housing construction business is booming. The Gweru city council roads engineer revealed that Hamutyinei Road was resealed in 2009, but with the high traffic volumes found along the route, potholes of various sizes are already a common feature and the demand for frequent maintenance is beyond the current capacity of the local authority. The city engineer felt that with the current challenges bedevilling the city council, Hamutyinei Road was in a good state despite the existence of occasional potholes. The main affected area in Mkoba 6 and 7 was the intersection of Paradza and Chilimanzi Roads where five potholes with circumferences above 301 cm were identified. These were mainly due to poor or lack of maintenance work done on Paradza Road. Fig. 5 shows the distribution of sampled potholes in villages 6 and 7 of Mkoba high density residential area.

Fig. 5 Distribution of potholes on sampled streets in Mkoba 6 and 7.

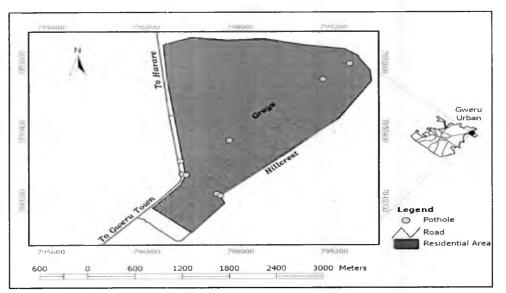
has since been abandoned as it resembles a gravel road. There has been extensive soil filling on the road. Grays Road has eight potholes which are generally spaced. The biggest pothole recorded along this road measured about 510 cm in circumference, 236 cm in diameter and had a shallow depth of about 0.8 cm. Shallow depths indicate that Grays Road has a strong and thick surface and the tar surface is only giving in due to age, stress caused by tyre pressure and climatic variations. Although potholes in this area are few, majority of them are large (60%) whilst 40% are medium size. This implies that there has been little work done on maintenance recently as there is no much formation of new potholes but continued freaking of the already existing ones. The few potholes found on Grays Road can be attributed to the aging of the roads and little or no maintenance services by the city council. Ridgemont suburb roads are not frequently maintained because among other reasons. The suburb's residents are less influential politically as well as in council matters. Fig. 6 shows potholes on sampled roads in Ridgemont low density suburb.

Fig. 6 Potholes on sampled streets in Ridgemont residential area.

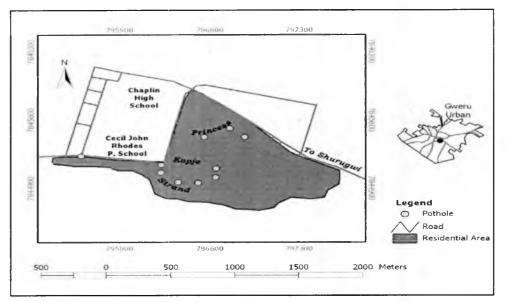
This suburb has roads with the least amount of damage compared to all the other sampled residential areas. Among the four sampled roads only Strand Street had two large potholes with diameters of 212 cm and 186 cm, depths of 3.56 and 2.8 cm and circumferences of 528 cm and 394 cm, respectively. These potholes are a result of road weakening due to overgrown road side tree-roots prying laterally below the surface leading to the development of road surface cracks. The cracks promote water infiltration and are therefore both widened and deepened by vehicle movement forming the potholes that were observed. Kopje Road, George Avenue and Princess Street are in perfect condition despite their advanced ages. These roads have been resistant to weakening caused by water infiltration because they were constructed at a gradient that facilitate good drainage. In addition, the low density suburbs such as Kopje are homes to some of the most influential individuals in the city such as high ranking city fathers, political heavy weights and top business people. This results in streets in these

Fig. 7 Potholes on sampled streets in Kopje residential area.

suburbs receiving urgent attention whenever their conditions deteriorate. Some points where signs of surface freaking due to aging were evident were however recorded but they were not well developed to be a cause for concern. However, this is the stage at which maintenance should be done to neap the problem whilst it is still in the buck and keep both maintenance and vehicle damage low. Fig. 7 shows pothole positions in Kopje low density suburb.

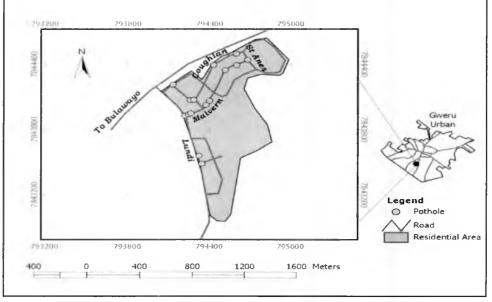
Lundi Park, a medium density residential area, had clear signs of negligence as far as road maintenance is concerned. The potholes in this residential area range from 66 cm to 337 cm in circumference, 25.3 cm to 168 cm in diameter and depths between 0.96 cm and 3.6 cm.

Most potholes are on Malvern Street where eight potholes were recorded and 83% of these were on the centre of the road with an average depth of 1.83 cm. 67% of the potholes were small, 17% were medium and 16% large in size.

The big proportion of the small potholes shows that there are higher rates of pothole formation associated with the rain season. The low gradient of the roads promotes the accumulation of water thereby weakening road surfaces that causes potholing of several sections. This is worsened by little or lack of timeous maintenance work to arrest further road deterioration in the residential areas. Fifteen potholes were recorded on the sampled streets in Lundi Park suburb as shown in Fig. 8.

Fig. 8 Potholes on sampled streets in Lundi Park residential area.

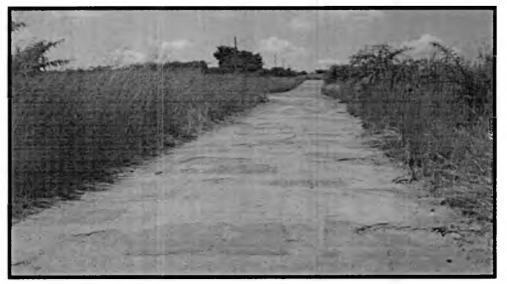
There is no doubt that by any standards, roads in this area are in a very dilapidated state with little patches of tarmac remaining behind predominantly gravel surfaces. Most commuter omnibus owners whose vehicles ply these routes complained of serious mechanical damage to vehicles warranting high frequency of repair services and raising the costs of the transport business in the area. In addition to the causes of poor road conditions in the area already stated, the roads in the area particularly Murified Road are frequented by heavy vehicles carrying construction sand further accelerating the rate of deterioration of the roads in the area. In the inner areas of the suburb, commuter omnibuses are the main vehicle traffic. These have also caused their own fare share of damage along Turnberry, Rosemere and Gulane roads as evidenced by the presence of some long elongated

Fig. 9 Aged and neglected Murifield road strip in Ivene residential area.

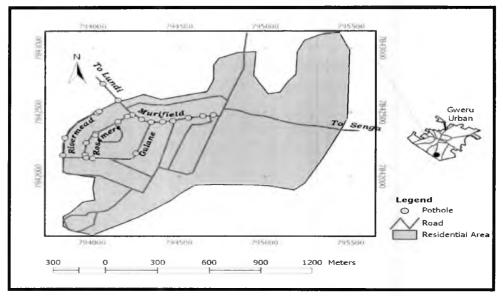
Of all the potholes that were recorded on sampled roads in Ivene residential area, 47% were large, 33% were medium and 20% were small. The largest pothole which resembles a wilderness ditch along Murifield Road has a circumference of 598 cm, depth of 8.7 cm and a diameter of 305 cm. This poor condition of roads in Ivene is a result of a combination of factors chief among them being aging, substandard construction, gentle gradient promoting water infiltration, weak unconsolidated sand soils that dominate the area and lack of maintenance. A stretch on Murifield Road leading to Ivene shops shown in Fig. 9 bears testimony to what commuter omnibus drivers and the suburb residents called "the suburb of the bumpy roads".

Fig. 10 Potholes on the sampled streets in Ivene residential area.

potholes along these inner suburb roads. The recorded potholes are shown on the street map of Ivene in Fig. 10.

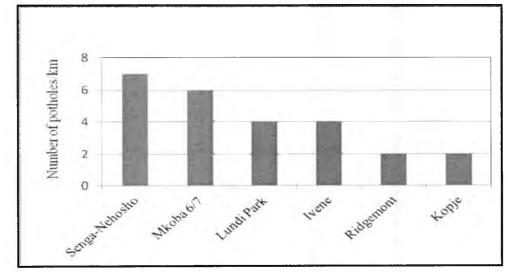
There are higher rates of pothole formation in the high density residential areas as compared to low density residential areas. In fact, the potholes follow the population density trend in the residential areas of Gweru. High density residential areas have the highest rates of pothole formation per unit distance, followed by medium density suburbs and lastly low density suburbs of Kopje and Ridgemont as shown in Fig. 11. This tallies with the city roads engineer's survey results in which she highlighted that the roads in high density residential areas are more prone to pothole development due to the low cost surfacing applied as

Fig. 11 Number of potholes found on sampled roads per kilometre in residential area.
